# Interstate 90 – Snoqualmie Pass East

## VISUAL IMPACT ASSESSMENT DISCIPLINE REPORT

January 2002

**Washington State  
Department of Transportation**

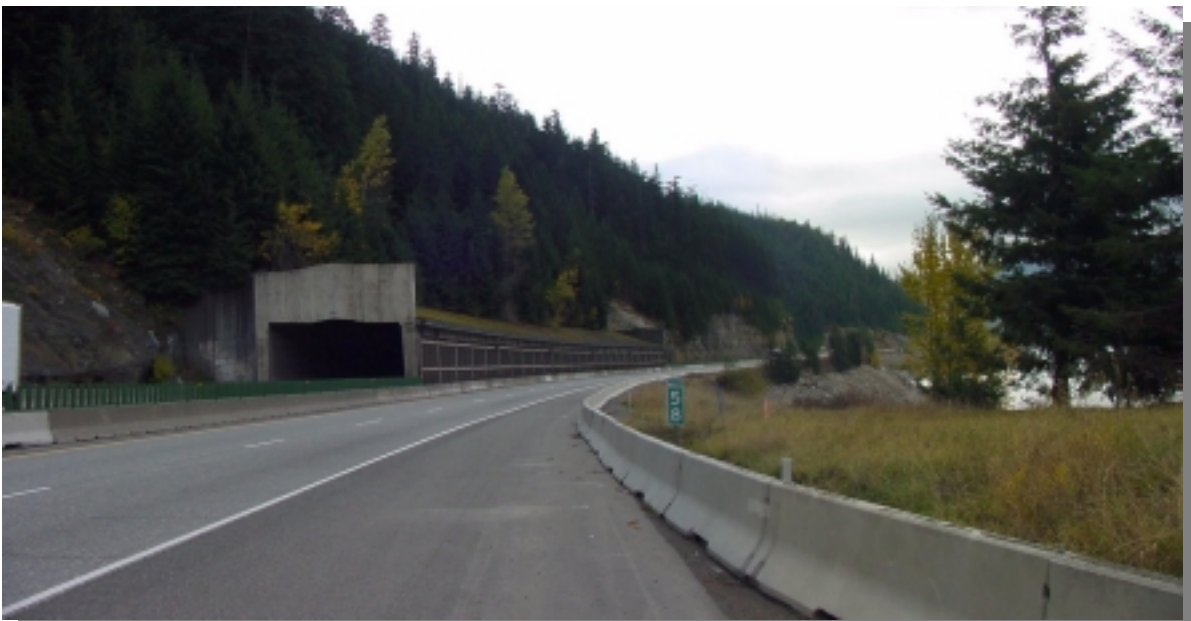
**Figure 3. Topography at Mile Post 58 - the snow shed**

The John Wayne Pioneer Trail, a part of Iron Horse State Park, runs along the western shore of the lake and has views toward I-90. There are brief views of the road from Forest Service Road 4832, which runs parallel and above I-90 to the east. Currently, concrete barriers form the median between the two lanes of traffic. Figure 3 shows the topography at Mile Post 58.

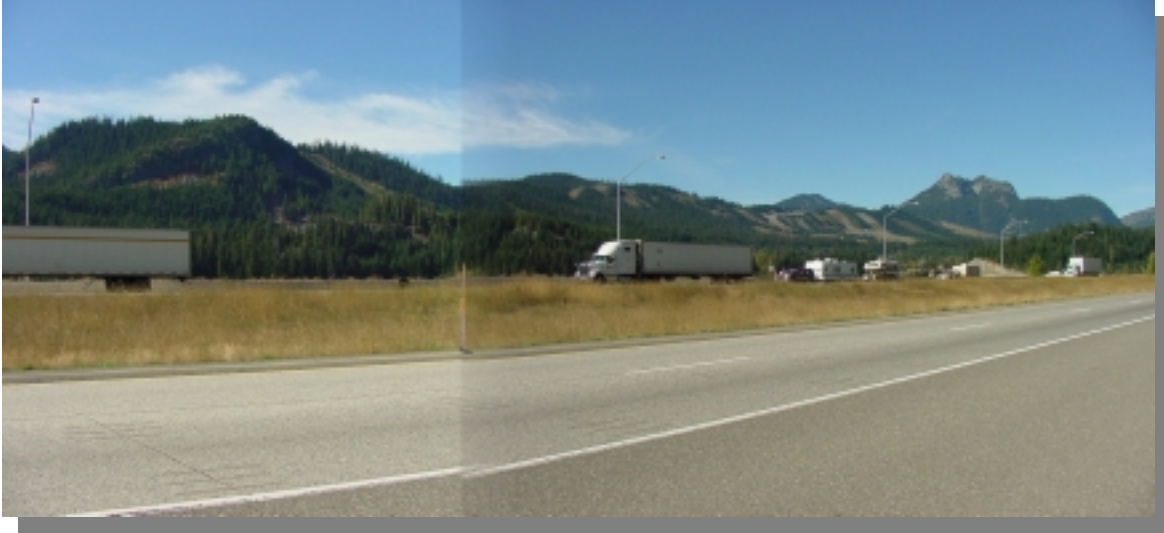
**Figure 11. Key view 1 - West bound MP 56**

Key View 1 looks west, toward the mountains beyond the lake and north, toward the ski slopes at Snoqualmie Summit. The existing view, shown in Figure 11 includes the chain off lanes and lighting provided for that activity. The view is toward the northwest.

Grasses in the median dominate the foreground. Vehicles traveling eastbound and stopping in the chain off lanes, are the principle visual elements in the middleground. In the background, second-growth Douglas fir forests cover the mountains to the west and cleared areas for ski runs are seen on the forested slopes to the northwest. Bryant Peak can be seen in the distant background on a clear day.

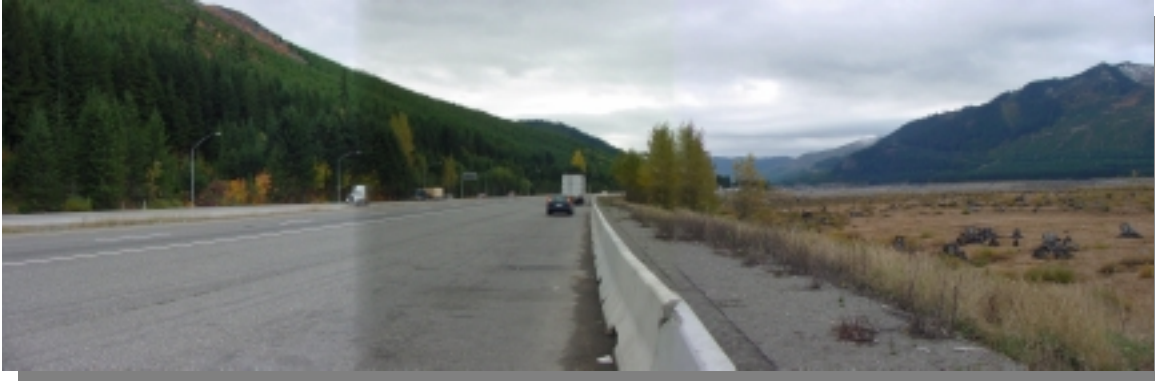
**Figure 12. Key View 2 - Eastbound, MP 56**

Key View 2 has a foreground view of the road. Middleground views are of cottonwood and Douglas fir trees, shrubs, grasses, and near lake or lakebed views. Background views are of the lake, the opposite shore, distant hills, and the mountains beyond. This is a popular place for trucks and visitors to stop because of the shoulder width and because it is the first opportunity to view the lake and the only place to stop along its eastern shore. This view can be seen in Figure 12.

The view is memorable and has a high degree of vividness. The road is the principle development within the viewshed. Beyond the road, the view is relatively intact. Its intactness rating is moderately high. This key view has a moderately high degree of unity.

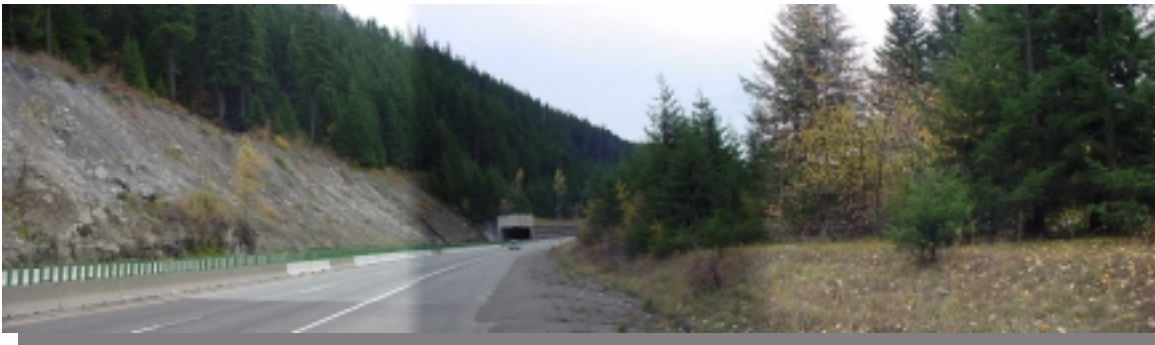
**Figure 13. Key View 3 - Eastbound MP 57.5**

Existing views, seen in Figure 13, are of the snow shed over the westbound lanes of traffic and of trees between the lake and the highway. Vegetation consists of grasses on the right-hand shoulder. There are Douglas firs and native cottonwoods between the road and the lakeshore. Trees, consisting of Douglas firs and cottonwoods are growing on top of the snow shed and on the slope above the steep rock cut along the highway to the left.

The foreground view is of the roadway and the median Jersey barrier. Middleground views are of the trees between the road and the lakeshore. Background views are of the snow shed and hills beyond.

This view too is somewhat memorable because of the snow shed. It has an average vividness rating because of the lack of water in the view. The road and the snow shed are the principle developments within the viewshed. Beyond the road, the view is relatively intact therefore; this view has a moderately high intactness rating. This key view has an average unity rating because of the steep, unvegetated slopes to the left of the highway.

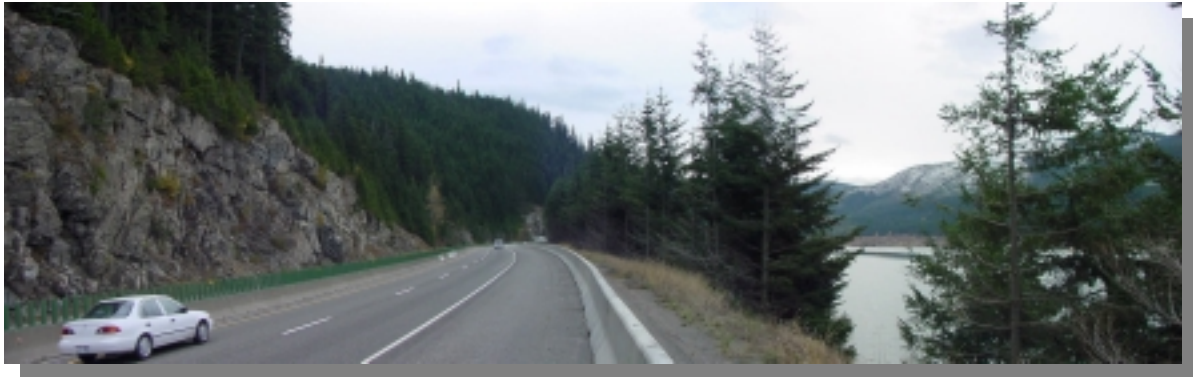
**Figure 14. Key View 4 - Eastbound MP 58.5**

Existing views at this key viewpoint are of rocks rising sharply on the left, the road seeming to point directly into the mountainside, and of the lake to the right. This is a dramatic view because of the contrast in textures from rock and vegetation to water. Foreground views are of the highway, the rock, and the Jersey barriers in the median and along the right shoulder. Douglas fir trees dominate vegetation here and provide some screening between the highway and the lake. This view can be seen in Figure 14.

Because of the difference in texture, the lake and mountain views, this scene has a high vividness rating. The only development in the scene is the highway; therefore this key view has a high intactness rating. It also has a high unity rating.

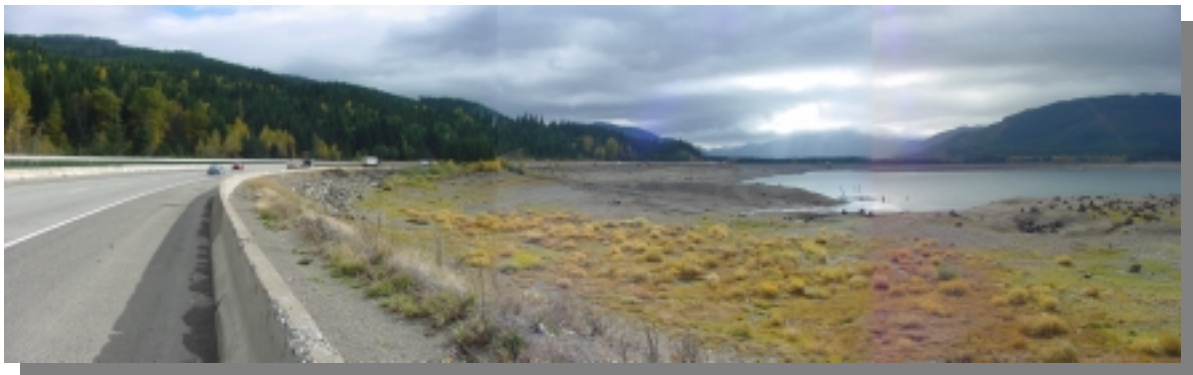
**Figure 15. Key View 5 - Eastbound MP 59.35**

The southern end of Lake Keechelus dominates this view. The road and Jersey barrier occupy the foreground. The middleground is of grasses between the road and the lake and of cottonwoods and Douglas firs on the left side of the road. The dam can be seen in the background as well as the mountains in the far distance. Beyond the dam, the Yakima River flows south to eventually join the Columbia River far beyond the project limits. Figure 15 shows Key View 5.

This view has a moderately high to high degree of vividness. The lake makes this scene memorable. The road and the dam are the two obviously manmade elements in this scene. While the dam represents development, its low profile relative to the surrounding landscape allows it to

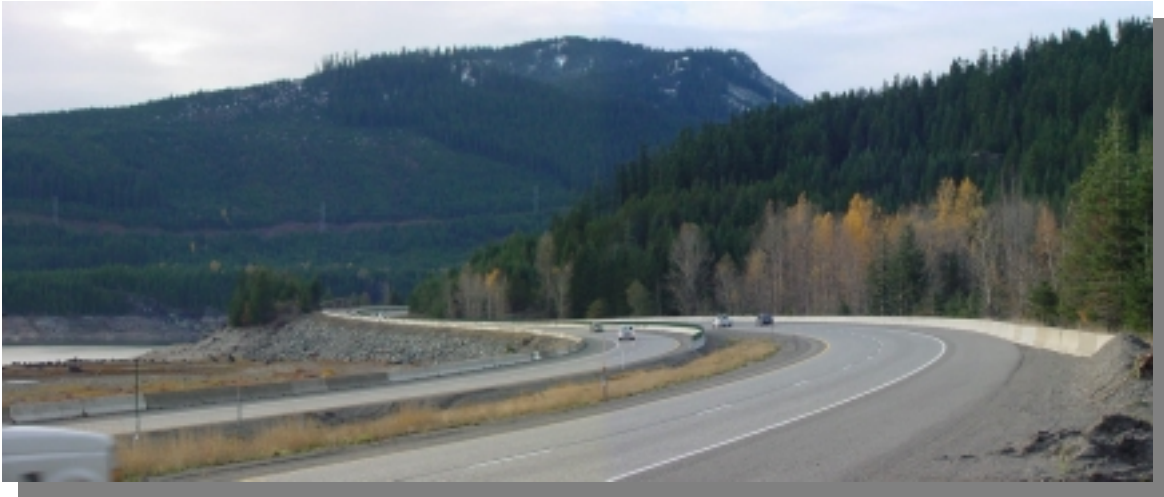
**Figure 16. Key View 6 - MP 59.85 Westbound**

This Key View looks north along Lake Keechelus on westbound I-90. The lake is to the left and the southern side of Slide Curve is directly ahead. The foreground is occupied by the highway and by vegetation to the right. Native grasses occupy the road shoulder and young Douglas fir trees and cottonwoods are growing on the eastern slope. The lake, highway, and vegetation on the right occupy the middleground. Slide Curve and the mountains to the northwest of Lake Keechelus are in the background. This view can be seen in Figure 16.

This view has contrasting topography: mountains, hills, and the lake; but the contrasts are not dramatic. The view of the lake enhances its vividness rating making it moderately high. Development is limited to the highway, transmission lines on the mountain across the lake, and distant logging roads on the mountains. Its intactness rating is moderately high. The overall unity in this scene is high because the road emphasizes and enhances the curve of the shoreline.

The six parallel lanes of traffic would enter and exit the tunnel straight ahead of the view in Figure 16. The two tunnel portals would span a distance of approximately 200 feet and there would be a large structure to house the ventilation system connecting and surrounding the tunnel portals.

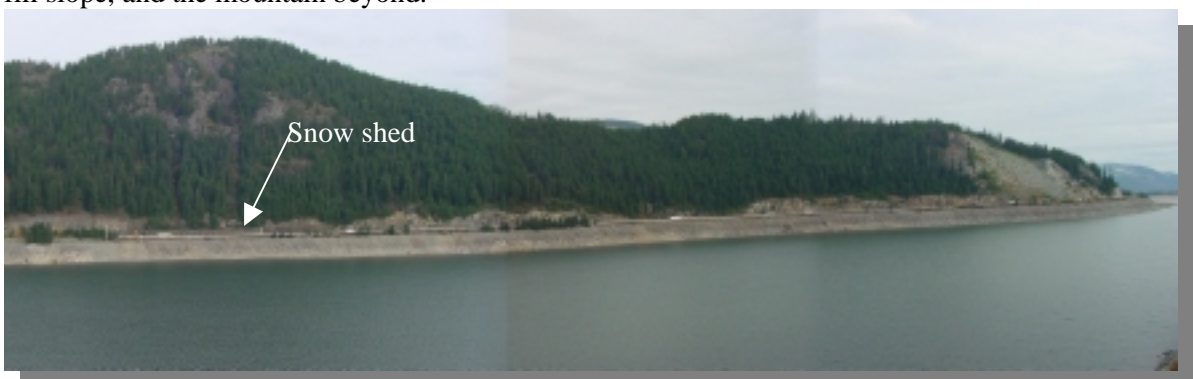
**Figure 22. Key View E - Snow shed from John Wayne Trail**

This key view is directly across Lake Keechelus from the snow shed on I-90. Figure 22 shows the avalanche chutes that lead to the snow shed. When seen from this perspective, the need for protection of drivers from the active chutes is clear. The foreground of the scene is the near shore water of the lake. Middleground is also of the lake. The background view is of the roadway, its fill slope, and the mountain beyond.

The water and the mountain in this view contrast with one another and make this a scene with a moderately high to high vividness rating. The road is the only development in the view. The unvegetated cuts in the rock to provide space for the road make it more visible from this distance

From Key View E, the roadway would disappear. Without mitigation, there would still be a horizontal line within the viewshed. However, the movement of cars and trucks would not catch the eye. Vividness ratings would be equivalent to those of the existing condition. Intactness and unity ratings would be high.

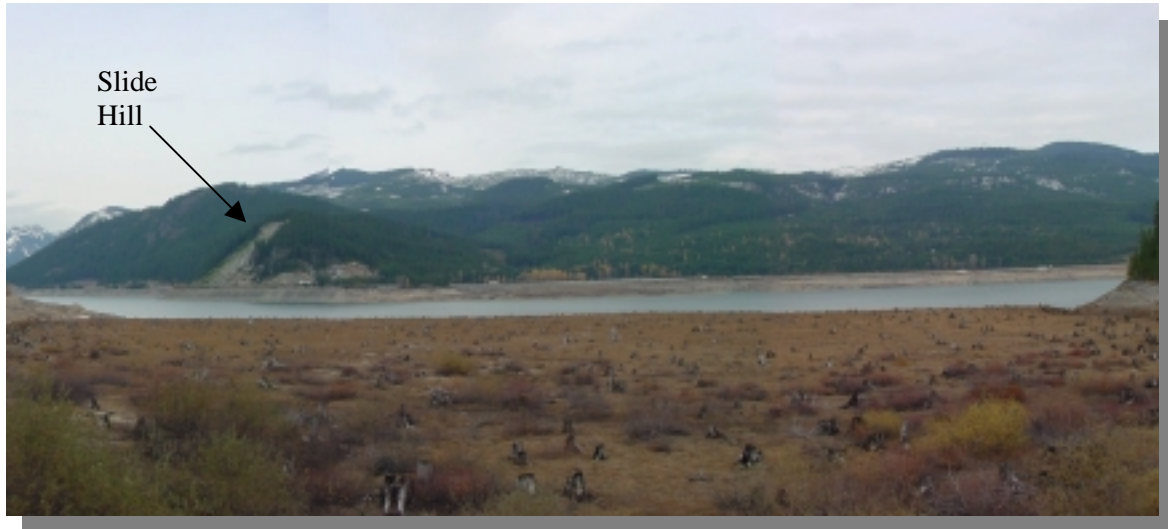
**Figure 23. Key View F - John Wayne Trail view of Slide Curve**

Views from the John Wayne trail are sweeping and dramatic, as seen in Figure 23. This view of Slide Curve to the left of center in the background shows the constant erosion that prevents vegetation from becoming established on the slope. Additional background views are of distant peaks. The foreground is occupied by vegetation along, and below the trail. The middleground is occupied by the lakeshore.

This view of the curving lakeshore on the east is dramatic. The mountains in the background and the lake in the foreground enhance that drama. This view has a high vividness rating. The highway is seen in the background as a narrow band at the base of the mountains. This scene has a high intactness rating. Visual unity in this view is also high.

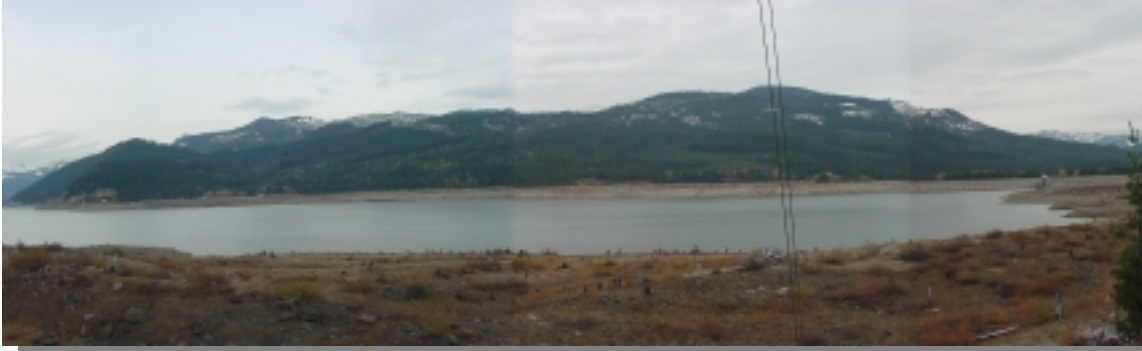
**Figure 24. Key View G - John Wayne Trail view from the south end of Lake Keechelus**

This is the first time the viewer traveling north on the John Wayne Trail sees Lake Keechelus. Native shrubs and Douglas fir trees make up the foreground view. The lake is in the middleground; mountains, the highway and the dam make up the background view. The road is visible only as a line, principally denoted by the fill slope and rock cuts necessary for the roadway width.

The combination of foreground vegetation, the lake and the long sinuous shoreline backed by forest-covered mountains is memorable. This scene has a high vividness rating. Development in this view fades into the background giving this scene a high intactness rating. Each element in the view blends together for a high unity score.

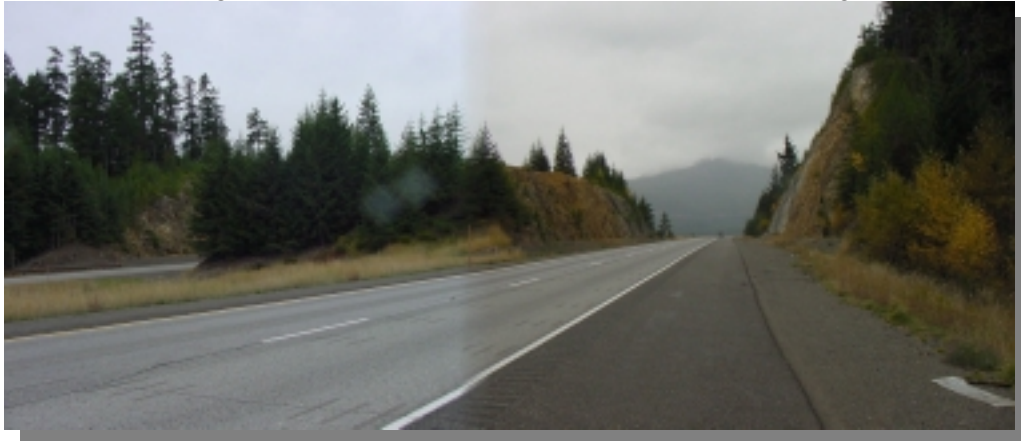
Figure 26. Key View 7 - Westbound MP 60.75

Key View 7 is the transition from Landscape Unit 2 to Landscape Unit 1 when traveling westbound on I-90 through the project corridor. At this point the traveler leaves the enclosure of the trees and can view long distances across the lake. This transition, seen in Figure 26, is made more dramatic by the rock cuts on either side of both the eastbound and westbound lanes. Native grasses grow in the foreground. Shrubs and Douglas firs grow in the middleground. The rock cuts are also in the middleground view. Tree covered mountains form the background view.

The landform in this view has a high vividness rating because of the constriction of the road by the rock walls on either side, which then open to a wide expanse. Vegetation is second growth of a medium to young age class. Overall, the vividness rating of this scene rates average because of the lack of water in the view. The road and the rock cuts are the only signs of development or encroachment. It has a moderately high intactness rating. The overall unity of the view is moderately high.

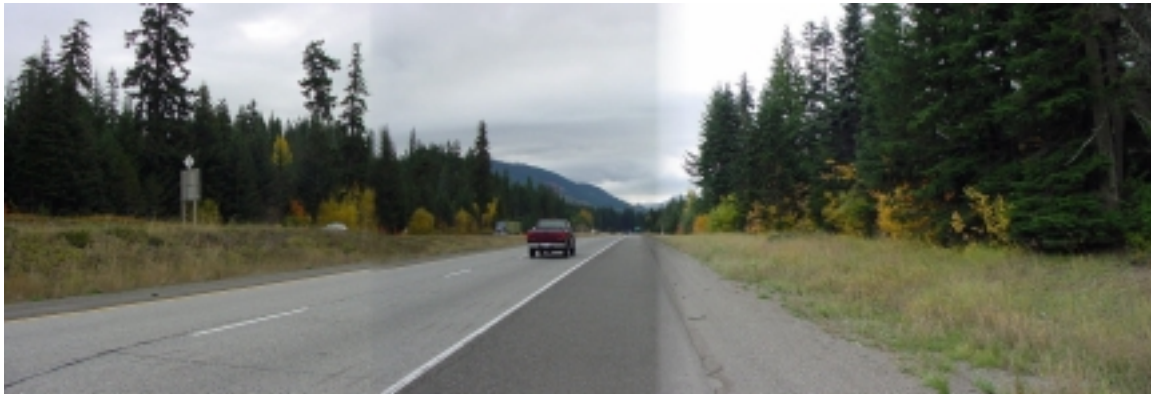
**Figure 28. Key View 8 - MP 61.75 Eastbound**

This Key View illustrates the sense of enclosure provided by second growth forest along the roadside. Douglas firs dominate the forest with some Black Cottowoods interspersed in the middleground. Trees appear to be 50 years or younger in age. Grasses form the foreground on the road shoulder and the median. The topography in this landscape unit allows for a medium width median.

This view, shown in Figure 28, has an average vividness rating. There are no sharp contrasts between landforms, materials, or water. The road is the only sign of development or encroachment. The intactness rating is moderately high to high. The trees and grass on both sides of the road provide a moderately high degree of unity in this view.

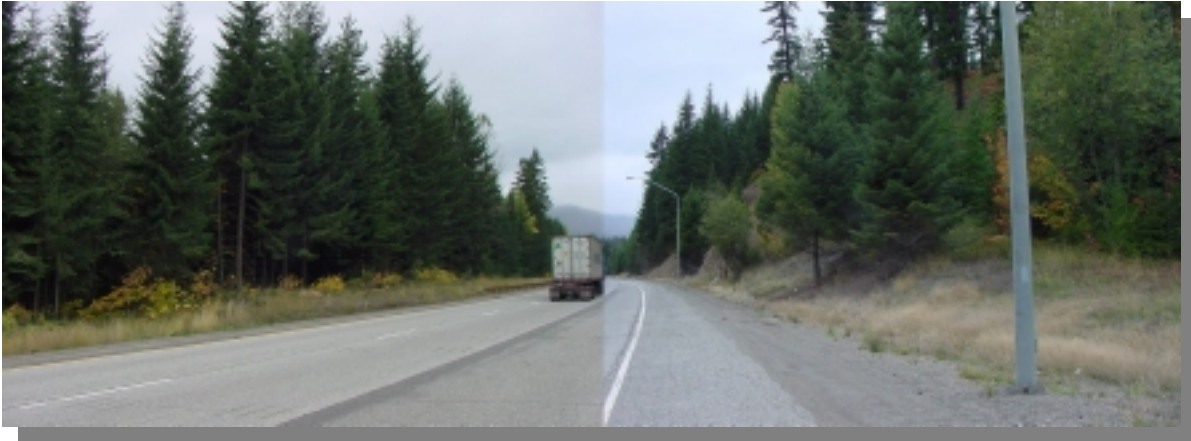
**Figure 29. Key View 9 - Westbound at end of Cabin Creek Road onramp**

Key View 9, seen in Figure 29, shows the westbound lanes with trees filling the median and enclosing the lanes on the right. This enclosure frames the view to the mountains in the background. Grasses, trees, and light standards form the foreground and well as the middleground views.

This view has a balance of landform, vegetation and manmade elements. It has a slightly above average vividness rating. There is some development, in the form of the road and lighting, but it encroaches only slightly. The intactness rating is moderately high. The overall unity of the view is moderately high.

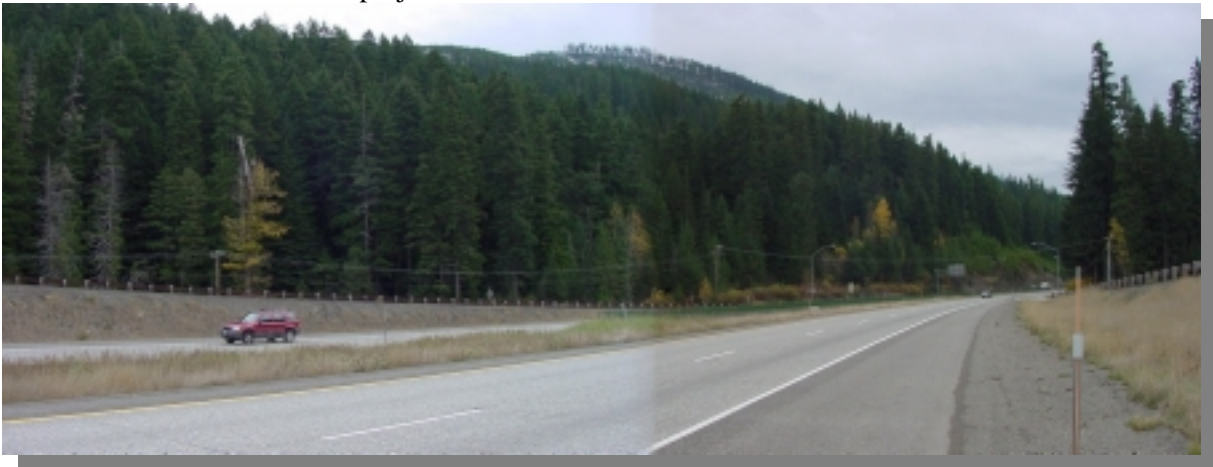
**Figure 30. Key View 10 - Eastbound near Cabin Creek Road**

Key View 10 has grass and the roadway in the foreground; the ramps, power lines, and Douglas firs and cottonwoods in the middleground; and logged mountains and sky in the background. There is a stand of mature Douglas firs, seen on the right hand side of Figure 30 just south of the eastbound onramp from Cabin Creek Road. These trees appear to be over 50 years old and are some of the oldest trees in the project corridor.

This view has a forest stand of moderate age, which provides a sense of enclosure to the road. In this particular view, the mountain in the background provides interest to the scene, which has an average vividness rating. There is some development in this view that encroaches because of the power lines and the sparse tree cover on the logged mountain in the background. Its intactness rating is average to moderate. Because of the encroachment, the unity rating of this view is average.

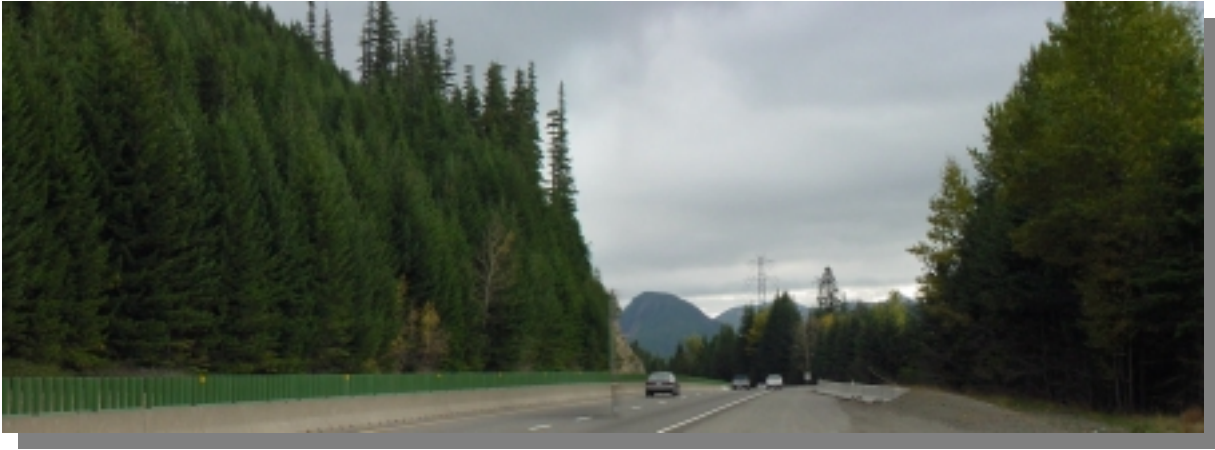
**Figure 32. Key View 11 - Eastbound MP 65.8**

Figure 32, a photo taken from this Key View, shows Douglas fir and cottonwood trees, the road, and the Jersey barrier median in the foreground. Trees and a transmission tower form the middleground view. Mountains are in the background. The trees screen the majority of the transmission towers and lines from the view of travelers on the road in this location.

Behind the power lines are slopes that have been logged in recent years. Vegetation on these slopes consists of fireweed, vine maple, young cottonwoods, and Douglas fir trees. See the photo in Appendix B.

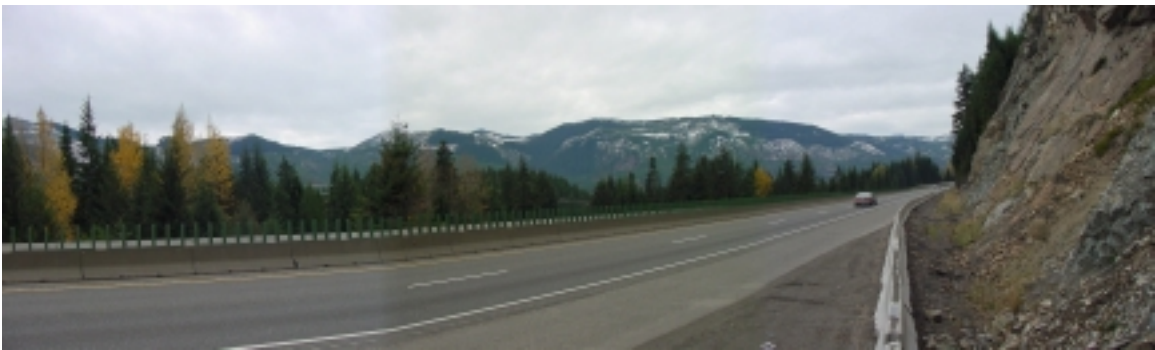
**Figure 33. Key View 12 - Westbound I-90 at MP 66.4**

The foreground elements in Key View 12, seen in Figure 33, are the rocky slope to the right, the highway, and the Jersey barriers on either side of the west bound lanes. Douglas firs and cottonwoods form the middle ground view. There are glimpses of the power lines between the trees in the middleground view. Mountains, which have been logged in places, form the background view.

The mountains visible in the background and the trees in the middleground make this scene one that is memorable. Its rating is just below average for vividness (because the lack of water in the view lowers the score). There is some development in the scene in the form of the highway and the power lines. In addition, there are visible logging traces on the mountains in the background. Intactness scores are just above average.

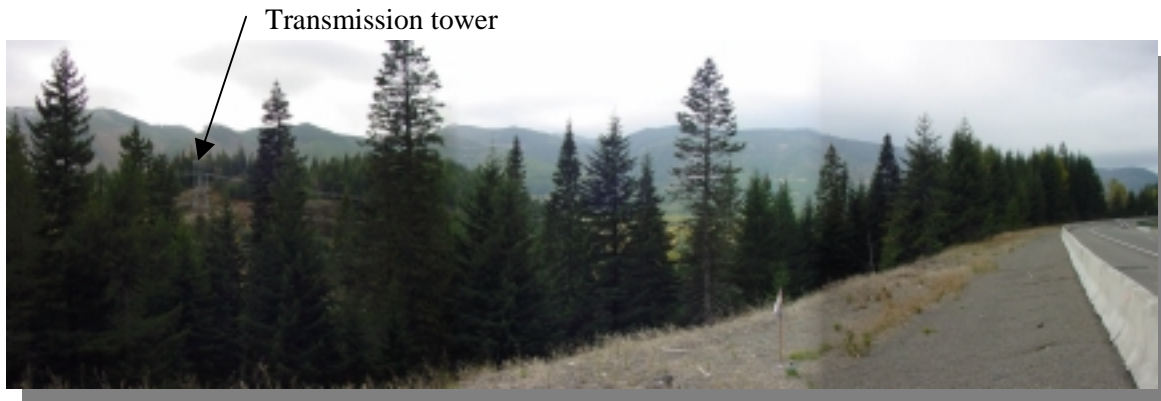
Figure 34. From roadside at MP 66

The trees screen the power lines except where there are gaps between trees. Unity in this view is moderately high. Figure 34 shows the power lines behind the trees at MP 66 and is included for information and was not analyzed as part of this study.

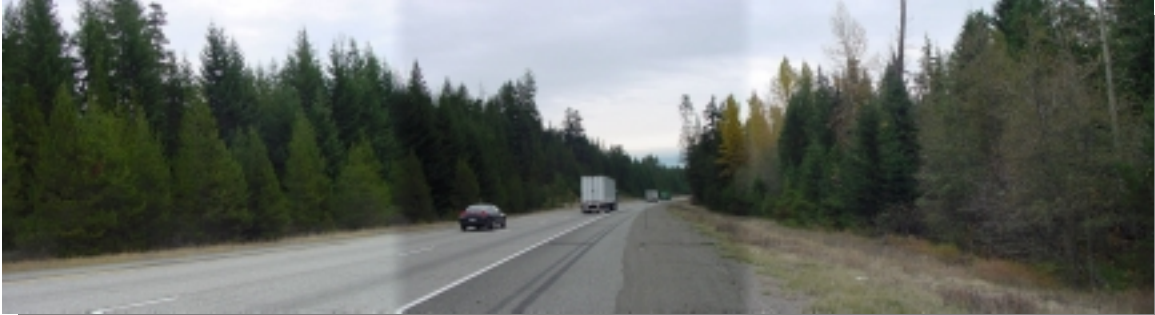
**Figure 36. Key View 13 - Mile Post 67.8 Eastbound**

This view illustrates the typical eastbound view in this northern end of Landscape Unit 4. The foreground view is of the road, nearby Douglas fir and cottonwood trees, and the native grasses in the median. Middleground views are of the same mix of trees. The background view is also of trees, with distant mountain views straight ahead up the centerline of the road. The character of this section of the roadside can be seen in Figure 36, below.

The densely vegetated median, the rolling landform, the second-growth trees, and the distant mountain views combine to give this view an average vividness rating. (Ratings would be higher with a water view – the average rating is an artifact of the FHWA rating system.) There is little visible development other than the highway. The intactness rating for this scene is high. It also has a high unity rating since the forest seems almost unbroken when seen from a traveling vehicle and travelers on the westbound lanes are not visible.

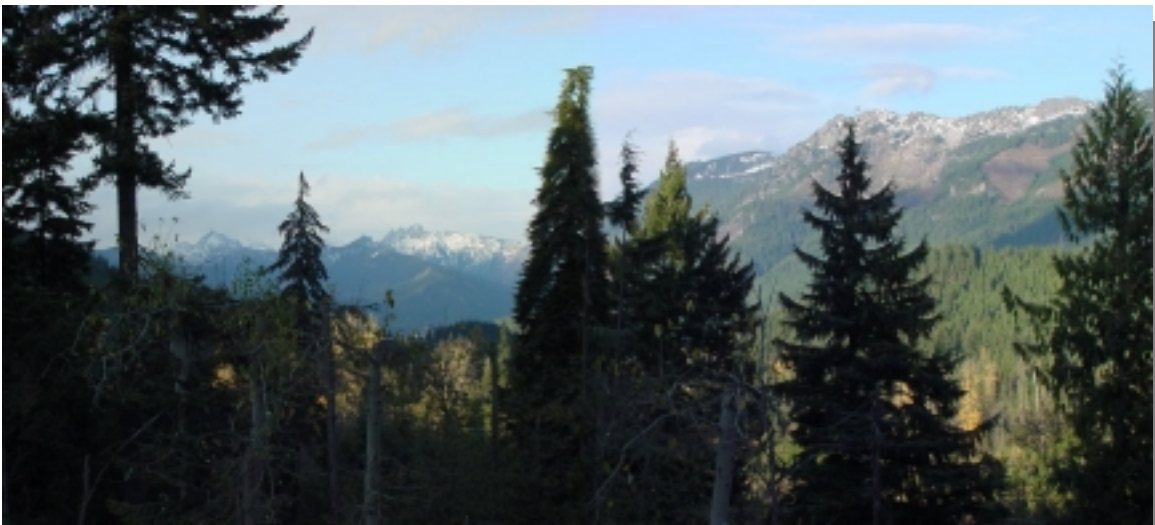
**Figure 37. View toward Alpine Lakes Wilderness from MP 67.8 Westbound**

This viewpoint has an excellent, but quick, view up the valley of Lake Kachess to the Alpine Lakes Wilderness. This view, seen in Figure 37, is for information and has not been rated.

This spectacular view is nearly blocked by second growth Douglas fir, Western Hemlock, black cottonwoods, and alders.

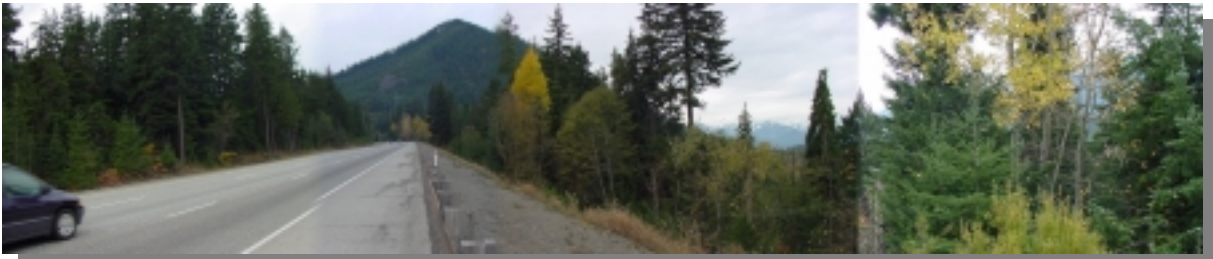
**Figure 38. Key View 14 - Westbound MP 67.8**

Figure 38 was analyzed for the study. The foreground view is of roadside vegetation. The middleground view is of the mountain straight ahead. The background view, just right of center, is of mountains in the Alpine Lakes Wilderness.

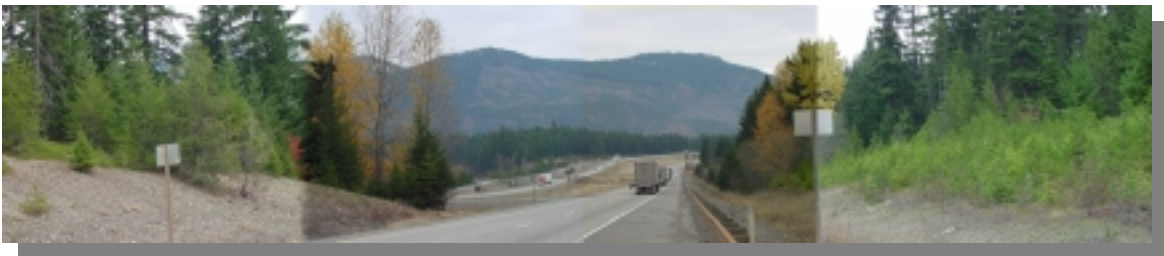
**Figure 39. Key View 15 - Eastbound MP 69**

This view of the southeastern end of the project corridor and of Landscape Unit 4 opens from a forested corridor to a more open landscape. This view has Douglas fir seedlings in the foreground, more mature Douglas firs and cottonwoods in the middleground, and forest covered mountains in the background. There is guardrail dividing the roadway from the roadside here instead of the Jersey barrier common in the previous Landscape Units. Figure 39 also shows the back side of traffic signs and their visibility.

This Key View has a vividness rating of just above average, again because of the lack of a water view. The road is the principle sign of development. It has a moderately high intactness rating. Its overall unity rating is moderately high.

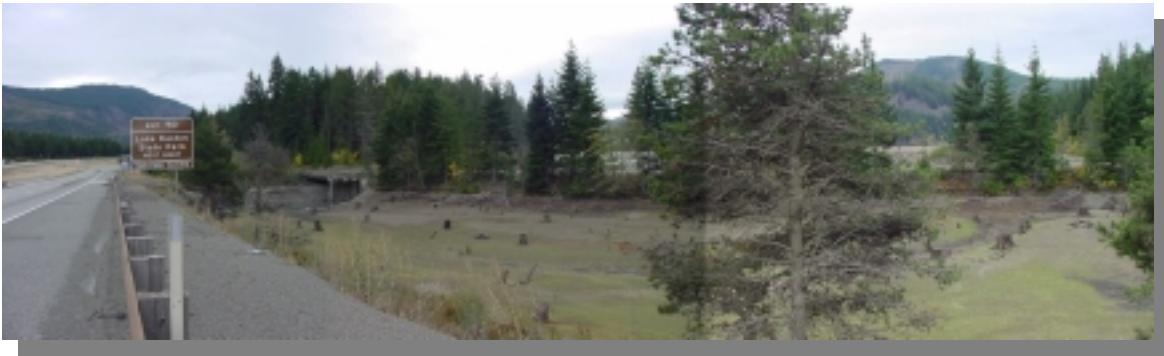
**Figure 40. Key View 16 - Eastbound MP 69.5 - Lake Easton**

This view is of an arm of the lakebed of Lake Easton between I-90 and the John Wayne Trail. This year, it is dry, but commonly this area is covered in water. The foreground is of the guardrail, a struggling Douglas fir, and native grasses. Middleground views are of the lakebed

and the Douglas fir forest at Lake Easton State Park. Background views are of recently logged mountains, as seen in Figure 40.

When lake levels are high, this is a very memorable spot on the drive through the project corridor. There are often children fishing from the bridge. The lake with its forested shore and the distant, rounded mountains give this a moderately high to high vividness rating. Road and traffic signs and the bridge over the Kachess River are signs of development. These cause some visual encroachment. Key View 16 has a moderately high intactness rating and a high unity rating.

This view from a popular fishing bridge has the eastbound bridge over the Kachess River in the middleground. Any changes to the bridge will affect the visual quality from this location. After construction, the view from this location is expected to remain the same as existing conditions.

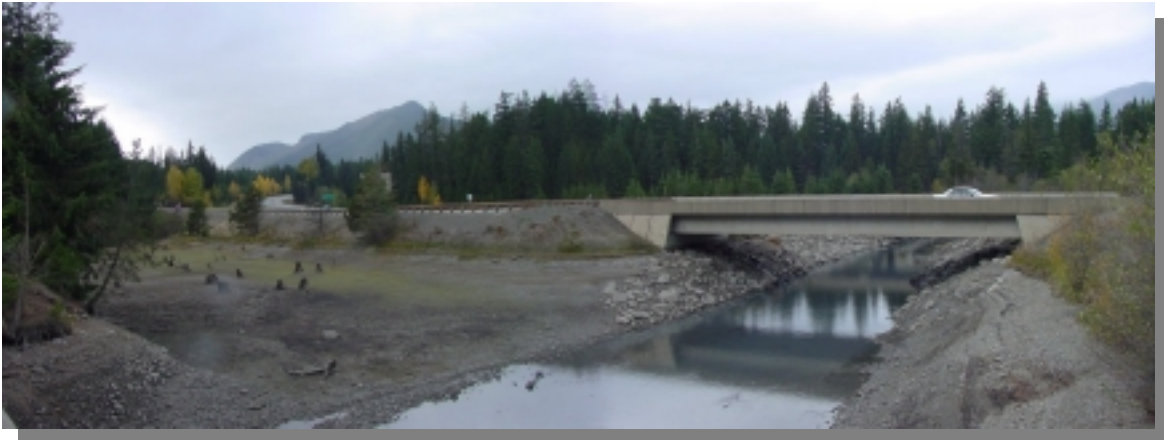
**Figure 41. Key View H - Toward I-90 from Kachess River Bridge on John Wayne Trail**

This scene has a water view, forested hills, and distant mountains. It has a moderately high to high vividness rating. The bridge in the middleground and the steep slopes are signs of development as is the highway in the background. The intactness rating is moderately high. The road disrupts the unity of this view for a rating of average.

Key View H was taken from the bridge of the Kachess River located on the John Wayne Trail at Lake Easton State Park. This is a popular bridge for fishing and is located near camping and picnicking areas. Foreground views are of the river and the lake edges. The middleground view is occupied by I-90's bridge over the river. Background views are of the highway as it diverges around the wide median with its forested hill. There are also mountains in the distance.

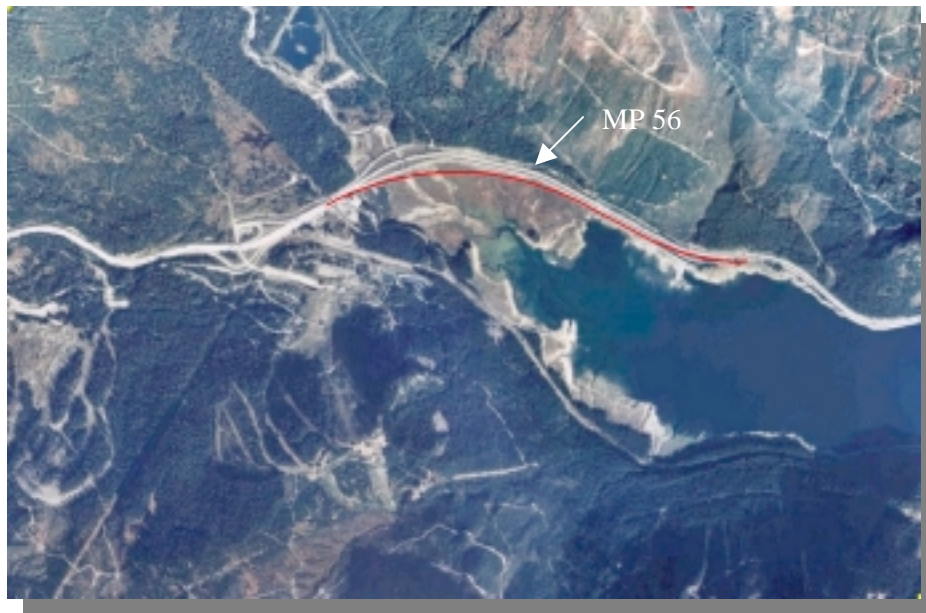
**Figure 42. Alternative alignment in Project Section 1**

The traveler would be slightly closer to the lake and there would be greater physical separation from Forest Road 4832. Existing vegetation would be removed during construction, lowering the vividness score because of the lack of roadside vegetation. The intactness score remains equal to that of the existing condition, but the unity score is lowered because the road is not blended into the surrounded landscape.

All alternative alignments would move the highway to the middle ground because the road alignment at this point would shift to the west. The alignment shift can be seen in Figure 42.

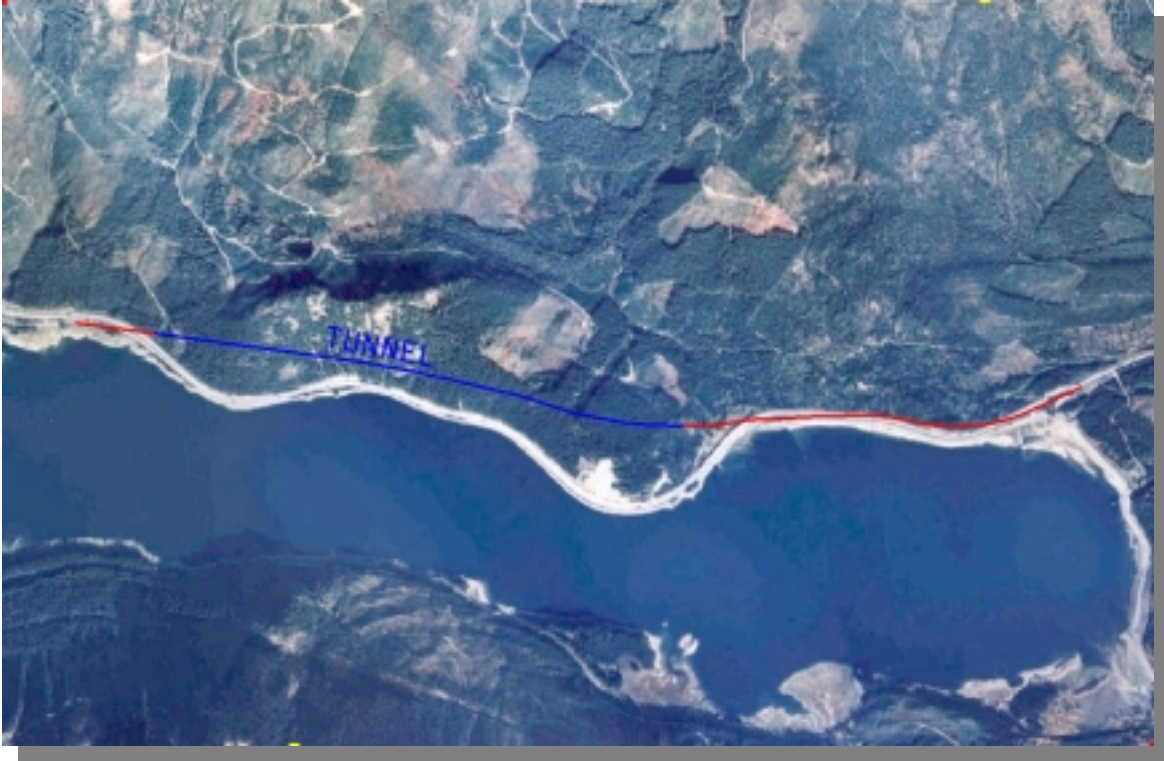
The tunnel in this alternative would be 1.9 miles long. The view of the lake, the surrounding mountains, and vegetation would be lost. Those factors combine to drop the vividness rating to low. A large structure would be needed at the tunnel portal to house the ventilation system

needed to move air into and out of the tunnel. There would be message reader boards and traffic lights in front of the tunnel entrance to warn travelers of any problems ahead. The visual intactness rating would be lower than the existing condition because of the high level of development. The visual unity inside the tunnel would be very low compared to the existing condition. Figure 43 shows the long tunnel alignment.

**Figure 43. Air photo with long tunnel alternative alignment**

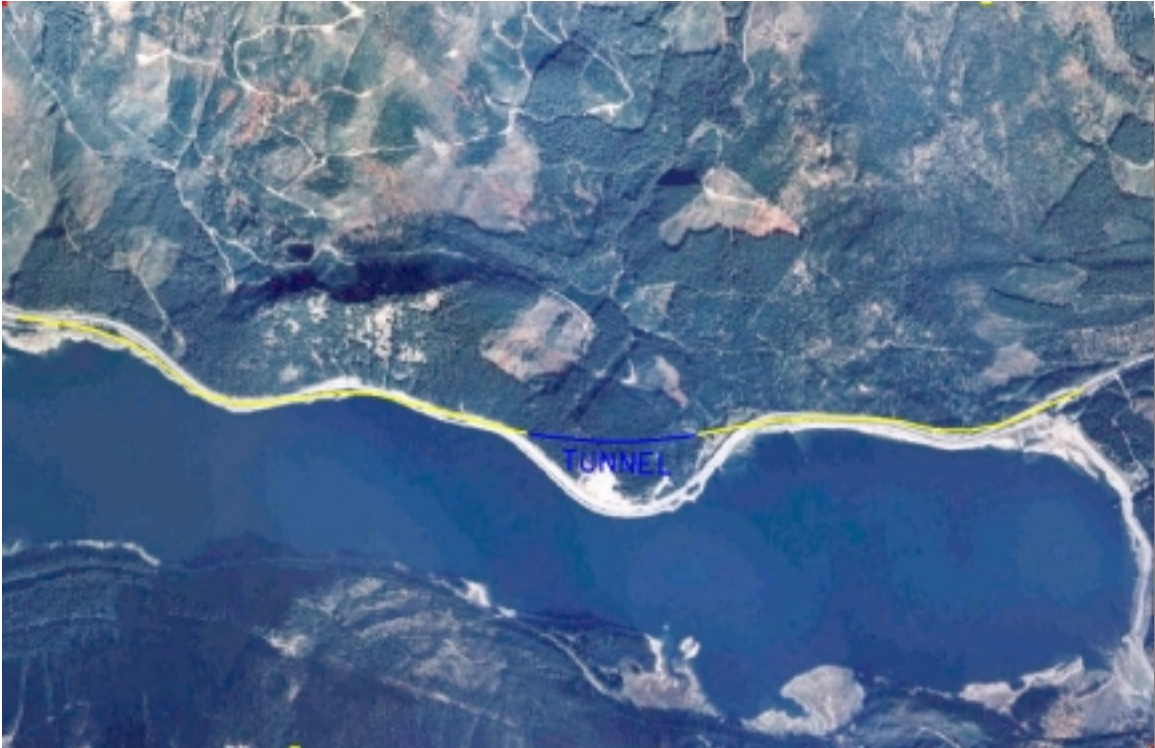
The short tunnel alternative would retain the views of the lake through this section of the project with the exception of the 0.6 mile tunnel. The horizontal alignment would be straightened, which would improve sight distance and bring the traveler closer to the lake. Vegetation would be removed for this alternative. At 60 miles per hour, the traveler would be in the tunnel for less than one minute. While in the tunnel, the traveler would lose the view of the lake and the surrounding landscape. Figure 44 shows the short tunnel alignment.

**Figure 44. Short tunnel alternative alignment**

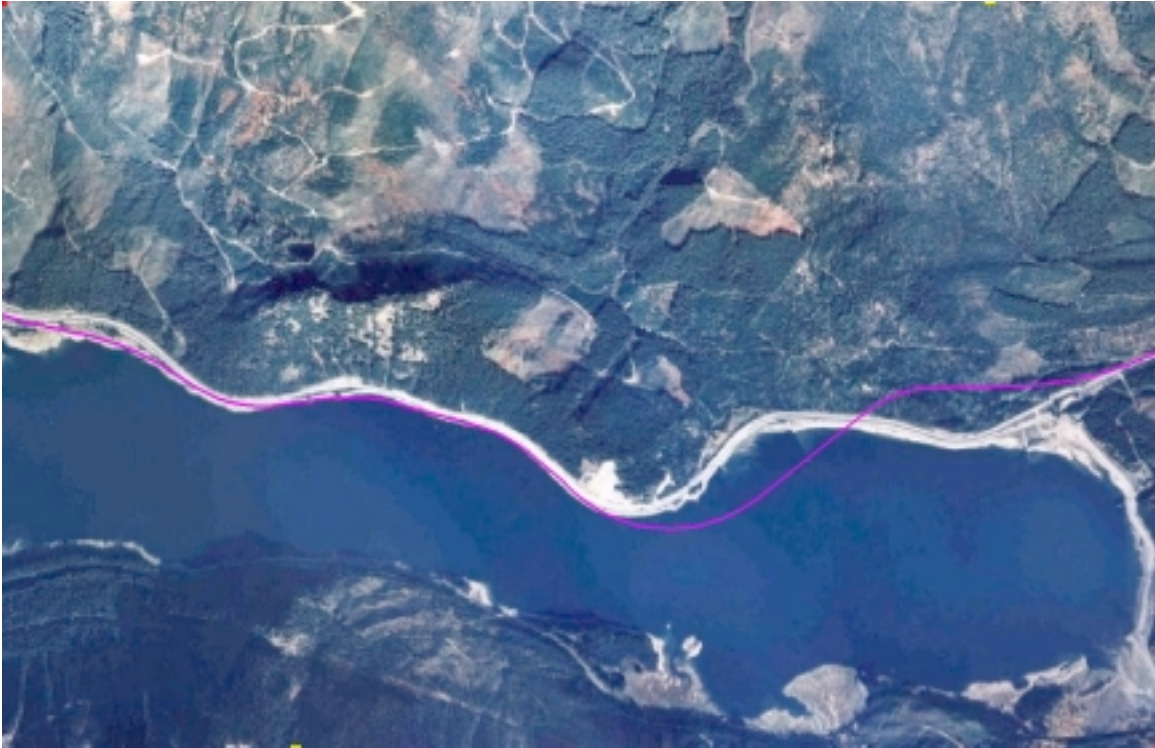
The road in Key Views 3 and 4 would be moved out into the lake on a long bridge, as seen in Figure 45. The avalanche chutes would pass below the bridges. Viewers would have an enhanced view of the lake. The wider, straighter road would have improved sight distance.

**Figure 45. Alternative with alignment into the lake**

The foreground view from Key View 5 would be of the restored roadbed. See Figure 45 for an aerial view of this alignment. The road would be to the west on a bridge in the middleground view. Travelers on the new alignment would have views of the lake on both sides of the roadway. Ahead, the road would depart from its current alignment and travel behind a hill. Mountains would be seen in the background.

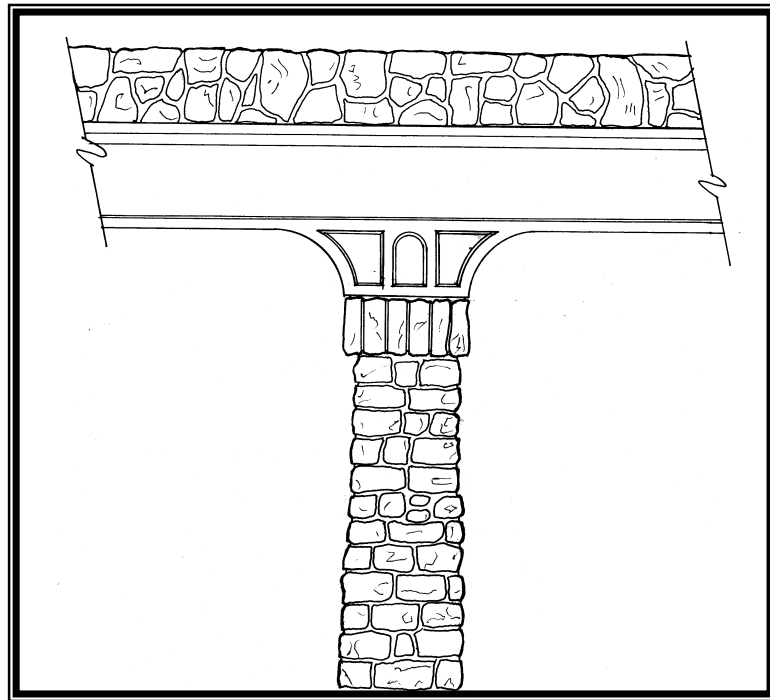
Architectural structures, such as bridge girders and railing, bridge abutments, tunnel portals, retaining walls, traffic barriers, and light standards will carry a Cascade theme, where possible, throughout the project corridor. The Figure 46 shows a bridge pier and railing designed with the application of the Cascade theme.

**Figure 46. Bridge pier and railing with Cascade design theme**

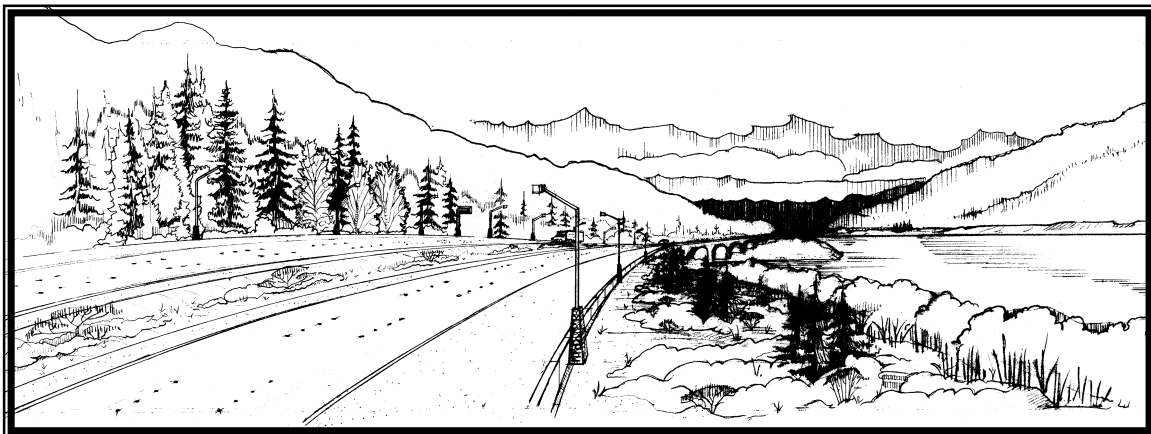
Native shrubs and groupings of trees would be planted between the road and the lake. In addition, the current roadbed would be removed and planted with a native Silver fir plant community. This will screen the highway and Forest Road (FS Rd) 4832 from one another. Increased trees and shrubs will blend the road into the surrounding area. Figure 47 shows the concept for mitigation around this viewpoint.

**Figure 47. Concept for Key View 1 Alternative A & B**

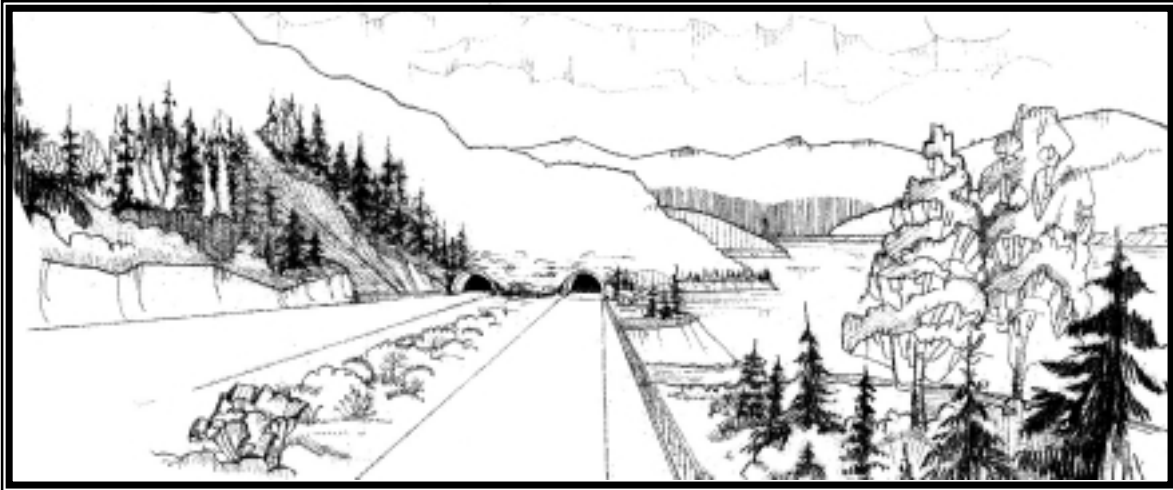
The tunnel portals and any associated structures, such as maintenance facilities, should be designed according to the architectural design standards with a Cascadian theme. Lighting inside the tunnel should provide glare-free illumination. A native forest plant community would buffer views from oncoming traffic and blend the roadway and structures into the surrounding area. The concept for Key View 3 after mitigation is seen in Figure 48.

**Figure 48. Concept for Key View 3**
